Environmental Surveillance of Vermont Yankee

Vermont Nuclear Decommissioning Citizens Advisory Panel
11 December 2023

Surveillance 2020 Vermont Yankee Nuclear Power Station

Report on Public Health Monitoring

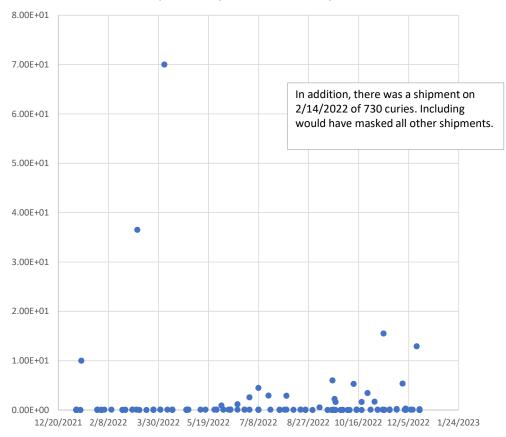
- NorthStar disposed of 7,480 curies in 126 shipments in 2022.
- The bulk was one shipment of 7,290 curies.

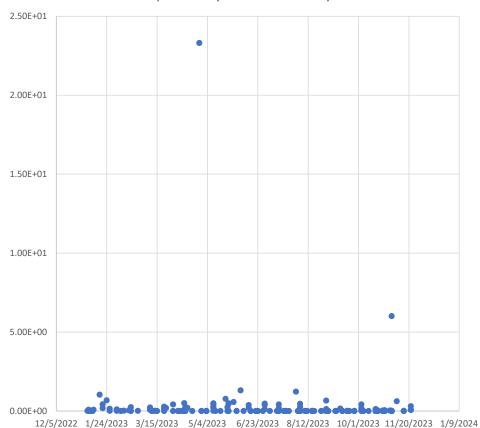
2023 Shipments by Date and Activity in Curies

- NorthStar disposed of 48 curies in 222 shipments through Thanksgiving, for a total of 48 curies.
- One shipment of 23.3 curies made up the most activity.
